3 BARRIERS

The listed barriers describe the problems encountered and perceived towards a “self-sustaining steadily growing solar thermal market in Thailand”

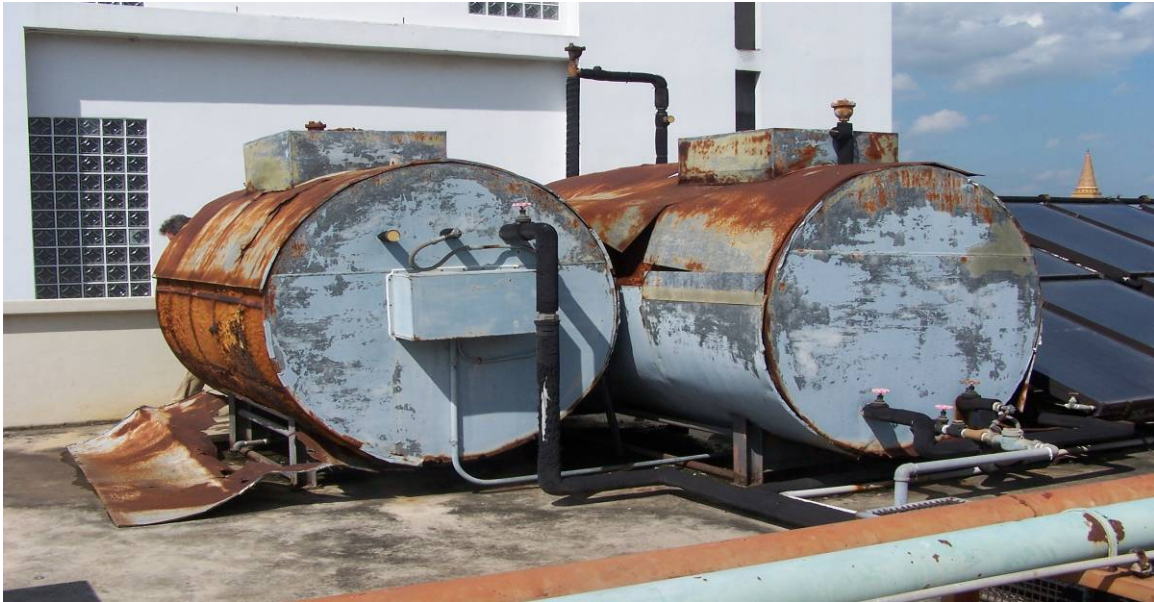
Figure 3.1 Picture of a neglected solar system In Thailand

Another observation made during the visits to several installations was that most of the installed collectors were completely covered with dust, sometimes the glass panes were broken and the collectors were corroded completely in some systems. In other words, the owners do not care about the installations, most of them even do not notice that the system does not work any more because non-residential systems have a compulsory back-up system and hot water is available without solar assistance.

- As indicated in earlier studies(see above) many collector arrays were covered with thick dust as they were not cleaned, piping systems were leaking and not repaired, non-functioning control systems were not replaced, etc.
- Inappropriate material and components used in the installation.
- Not to install measurement equipment: To save investment costs and customer are not willing to pay for this equipment as they were not convinced to need it!
